# Asbestos Survey Report

Flats 5-16  
Gander Drive  
Basingstoke

16<sup>th</sup> March 2005

This report contains the findings of a **Type 2 Survey** carried out at Flats 5-16 Gander Drive, Basingstoke on the 16<sup>th</sup> March 2005.

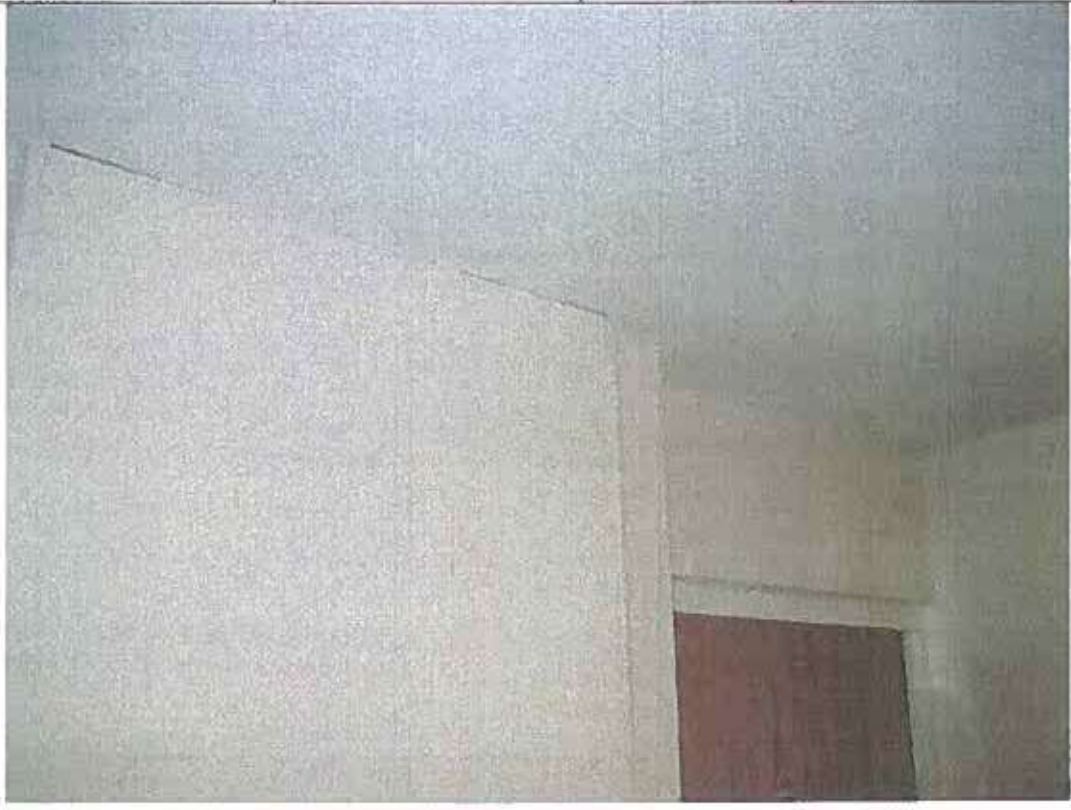
Client:	Mr Lewis		
Survey Address:	Flats 5-16, Gander Drive, Basingstoke.		
Building:	Purpose built 3-storey block of flats		
Location:	General throughout		
Survey Ref:	Gan/16305	Sample Ref:	Gan/16305/01
Photo Ref:	A	Date Taken:	16/03/05

Asbestos Type:	<b>No Asbestos Detected</b>		
Product/Use:	Wall & ceiling coating	Amount:	Total
Accessibility:	N/A		
Remarks:

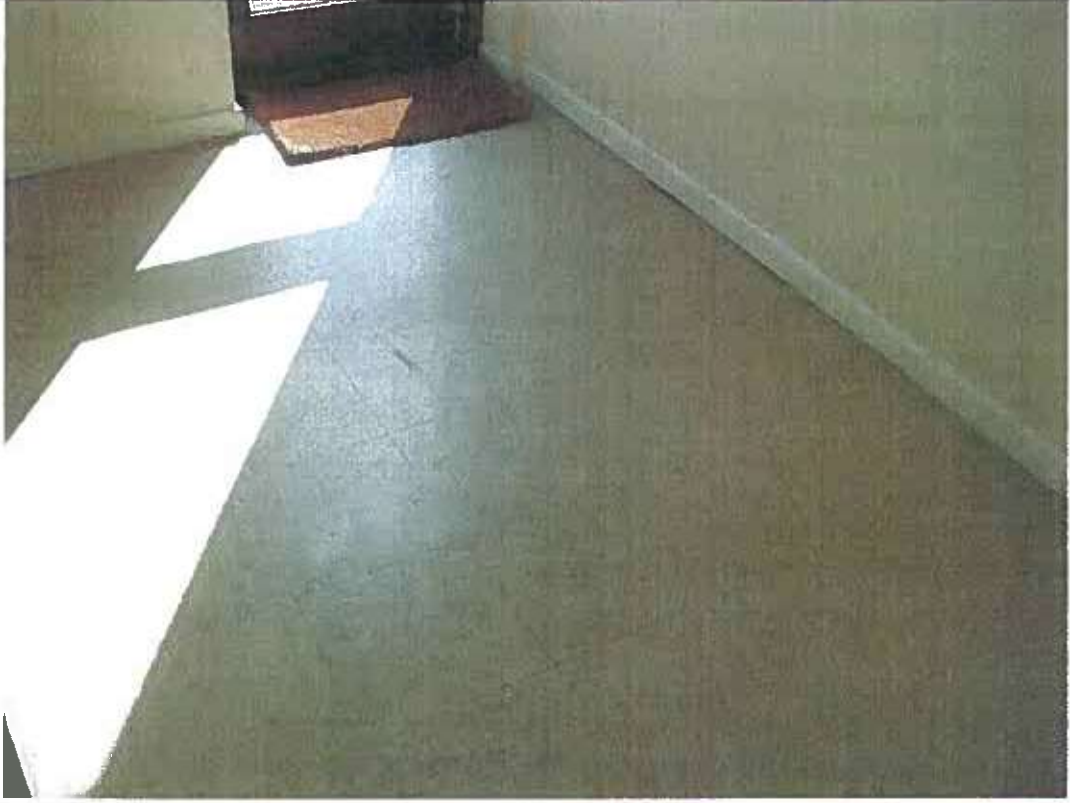
Client:	Mr Lewis		
Survey Address:	Flats 5-16, Gander Drive, Basingstoke.		
Building:	Purpose built 3-storey block of flats		
Location:	General throughout		
Survey Ref:	Gan/16305	Sample Ref:	Gan/16305/02
Photo Ref:	B	Date Taken:	16/03/05

Asbestos Type:	<b>No Asbestos Detected</b>		
Product/Use:	Floor tiles	Amount:	Total
Accessibility:	N/A		
Remarks:

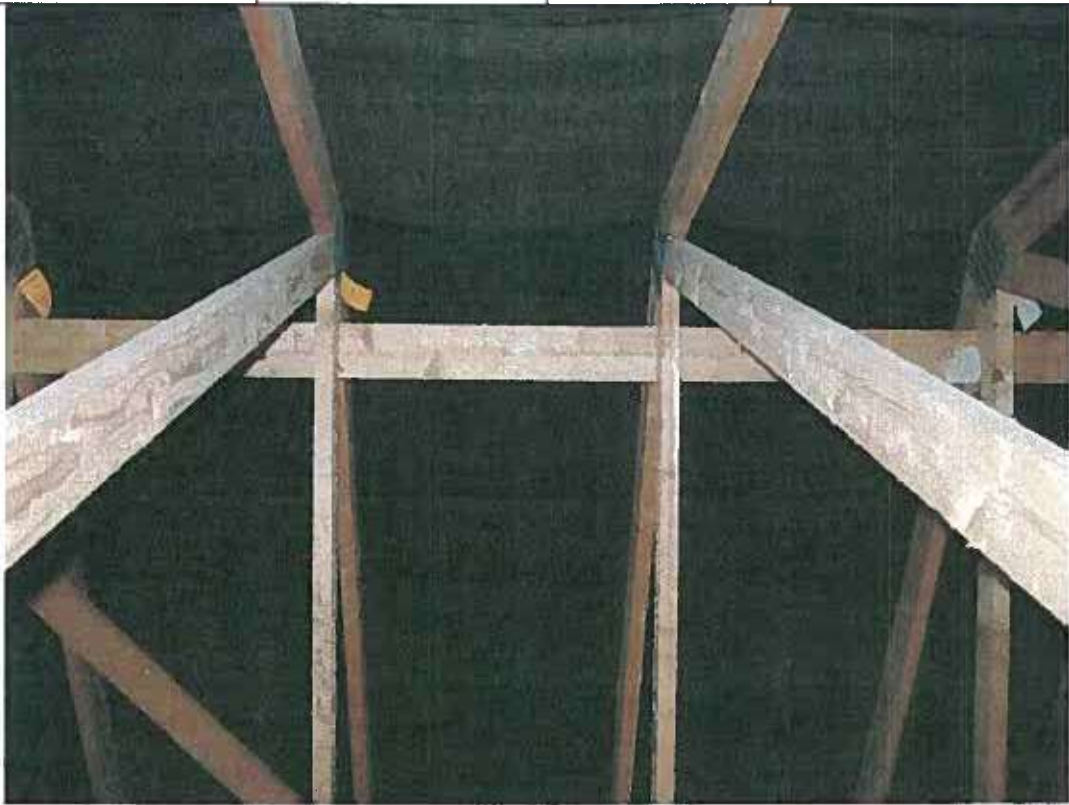
Client:	Mr Lewis		
Survey Address:	Flats 5-16, Gander Drive, Basingstoke.		
Building:	Purpose built 3-storey block of flats		
Location:	Loft space		
Survey Ref:	Gan/16305	Sample Ref:	Gan/16305/03
Photo Ref:	C	Date Taken:	16/03/05

Asbestos Type:	<b>No Asbestos Detected</b>		
Product/Use:	Roofing felt	Amount:	Total
Accessibility:	N/A		
Remarks:

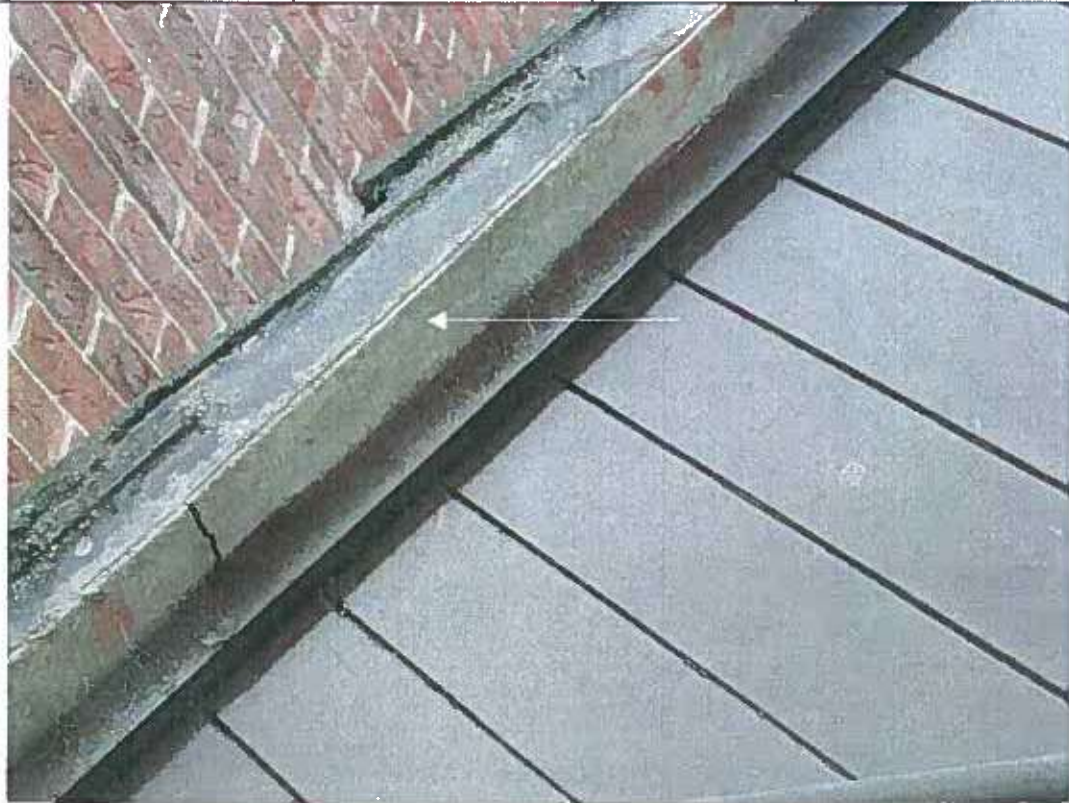
Client:	Mr Lewis		
Survey Address:	Flats 5-16, Gander Drive, Basingstoke.		
Building:	Purpose built 3-storey block of flats		
Location:	Exterior		
Survey Ref:	Gan/16305	Sample Ref:	Gan/16305/04
Photo Ref:	D	Date Taken:	16/03/05

Asbestos Type:	<b>Chrysotile</b>		
Product/Use:	Eaves soffit	Amount:	Total
Accessibility:	Poor		
Remarks:

SAMPLE NO.	LABORATORY REFERENCE	SAMPLE LOCATION	MATERIAL DESCRIPTION	ASBESTOS TYPE IDENTIFIED*
Gan/16305/04	103423	Exterior	Eaves soffit - cement	CHRYSTOLE
