# Type 1 Fire Risk Assessment

Reference Number:	FRA No. AGO/WELLMAN
Responsible person (e.g. employer) or person having control of the premises:	Wellman Property Management Ltd
Address of premises:	5-16 Gander Drive Basingstoke RG24
Person(s) consulted:	Wendy
Assessor(s):	Josh Godfrey, TIFireE
Quality Control Auditor (If Required):	John Godfrey, GIFireE.
Date of fire risk assessment:	26 <sup>th</sup> April 2021
Date of previous fire risk assessment:	Not known
Suggested dates for review: (1)	April 2022

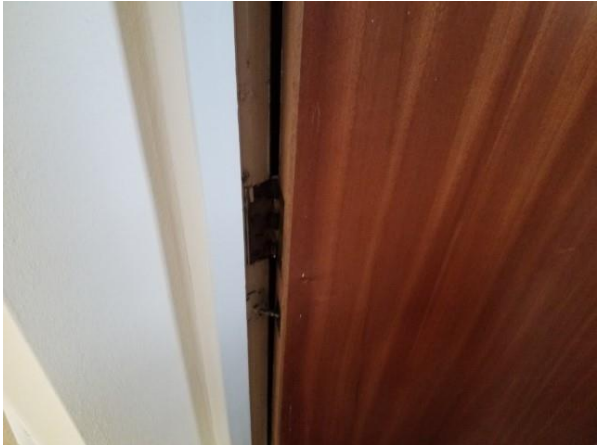
18.3	Comments and deficiencies observed:	
18.3	<p>From a brief sample inspection conducted during the course of this assessment, standards of compartmentation and fire stopping appeared to be adequate.</p> <p>From a sample inspection of unit 6 the entrance door appeared to be a notional fire door complete with 3 hinges and a perko closer. It is recommended that an overhead self-closing device and intumescent and cold smoke seals be fitted to this door in order to adequately protect the common areas.</p> <p>It is essential that each flat entrance door is a suitable fire door, providing a minimum of thirty minutes fire resistance, hung on three hinges and having a functioning self-closing device fitted that positively closes the door on the latch, together with smoke and intumescent seals. It is recommended therefore that the RP obtain written confirmation from each Leaseholder that their flat entrance door meets with the above requirements. Where there is any doubt as to the suitability of a flat entrance door the RP should instruct a competent person to inspect the relevant flat entrance door and provide advice on its suitability. Any shortcomings identified by this inspection should be addressed as a priority by upgrading or replacing the door.</p> <p>Flat entrance doors, the seals and the self-closing devices should then be subjected to a periodic inspection and maintenance schedule in accordance with the recommendations contained within the MCHLG Advice Note 16.</p>

05	18.3	<p>From a sample inspection of unit 6 the entrance door appeared to be a notional fire door complete with 3 hinges and a perko closer. It is recommended that an overhead self-closing device and intumescent and cold smoke seals be fitted to this door in order to adequately protect the common areas.</p>

MED	Client	
06	18.3	<p>It is essential that each flat entrance door is a suitable fire door, providing a minimum of thirty minutes fire resistance, hung on three hinges and having a functioning self-closing device fitted that positively closes the door on the latch, together with smoke and intumescent seals. It is recommended therefore that the RP obtain written confirmation from each Leaseholder that their flat entrance door meets with the above requirements. Where there is any doubt as to the suitability of a flat entrance door the RP should instruct a competent person to inspect the relevant flat entrance door and provide advice on its suitability. Any shortcomings identified by this inspection should be addressed as a priority by upgrading or replacing the door.</p> <p>Flat entrance doors, the seals and the self-closing devices should then be subjected to a periodic inspection and maintenance schedule in accordance with the recommendations contained within the MCHLG Advice Note 16.</p>	LOW	Client

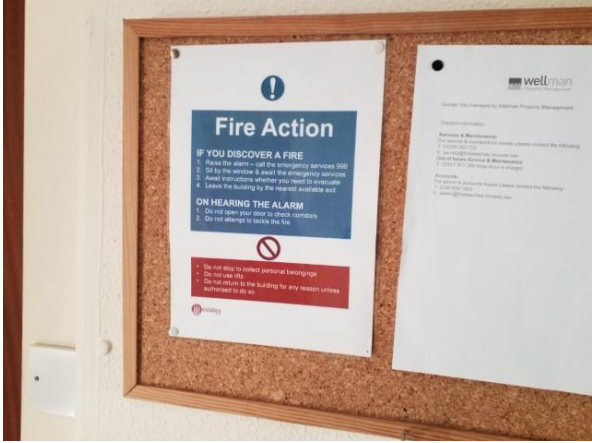
20.1	Reasonable standard of fire safety signs and notices?	<b>NO</b>
20.2	Comments and deficiencies observed:	
	<p>There are fire action notices installed throughout the common areas which refer to the incorrect evacuation strategy. It is recommended that these notices are replaced with suitable notices which should be completed in full and refer to the correct evacuation strategy which is stay put.</p> <p>Directional signage is not required for this premises due to the short travel distances and simple escape route layout utilising a single staircase.</p>

07	20.2	<p>There are fire action notices installed throughout the common areas which refer to the incorrect evacuation strategy. It is recommended that these notices are replaced with suitable notices which should be completed in full and refer to the correct evacuation strategy which is stay put.</p>
